Project No.
4365.002.024

December 2, 2024

Subject: Orinda Oaks Development
 Orinda, California

**ORINDA GEOLOGIC HAZARD ABATEMENT DISTRICT
 MONITORING – FALL 2024**

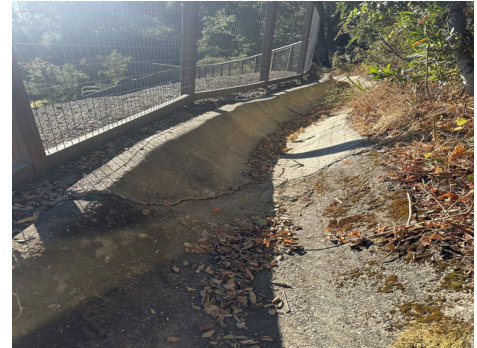
We have previously observed moderate cracks and offsets in the concrete ditch on the western portion of 320 Miller Court (Lot 9). We noted the offset in the concrete-lined drainage ditch on Lot 9 remained unchanged, with a measured ½-inch vertical displacement and ¼-inch horizontal displacement (Figure 1, Site Condition A). During this monitoring event, we observed an offset in the concrete-lined drainage ditch on Lot 11, with a measured 2-inch vertical displacement and 1-inch horizontal displacement (Figure 1, Site Condition B). The cracks and offsets do not appear to compromise the integrity of the concrete-lined drainage ditches. The GHAD will continue to monitor these conditions in future monitoring events.

Site Condition: A
Observation Date: 10/22/2024
Description: Crack and offset in concrete-lined drainage ditch west of Lot 9.
Recommendation: Continue to monitor.
Field Representative: QP

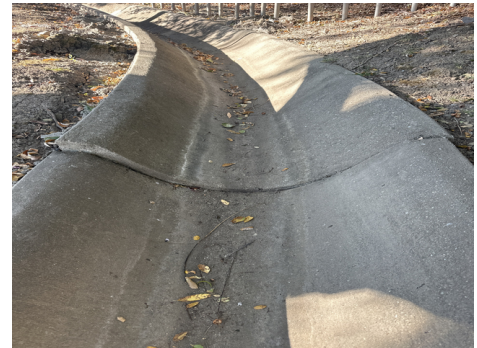
Site Condition: B
Observation Date: 10/22/2024
Description: Offset of concrete drainage ditch behind Lot 11.
Recommendation: Continue to monitor.
Field Representative: QP

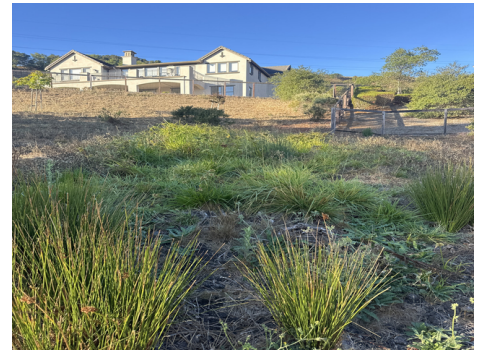
There is a slightly to moderately incised channel with moderate vegetation cover on the northeastern portions of 305 and 315 Miller Court (Lots 1 and 2). Minor to moderate areas of erosion and shallow slope instability were observed to be unchanged during this monitoring event, though some slope seepage was observed originating from Subdrain Outlet SK-1 (Figure 1, Site Condition C). The channel banks are oversteepened, and erosion and shallow failures will likely

Site Condition: C
Observation Date: 10/22/2024
Description: Seepage on slope coming from Subdrain SK-1.
Recommendation: Continue to monitor.
Field Representative: QP

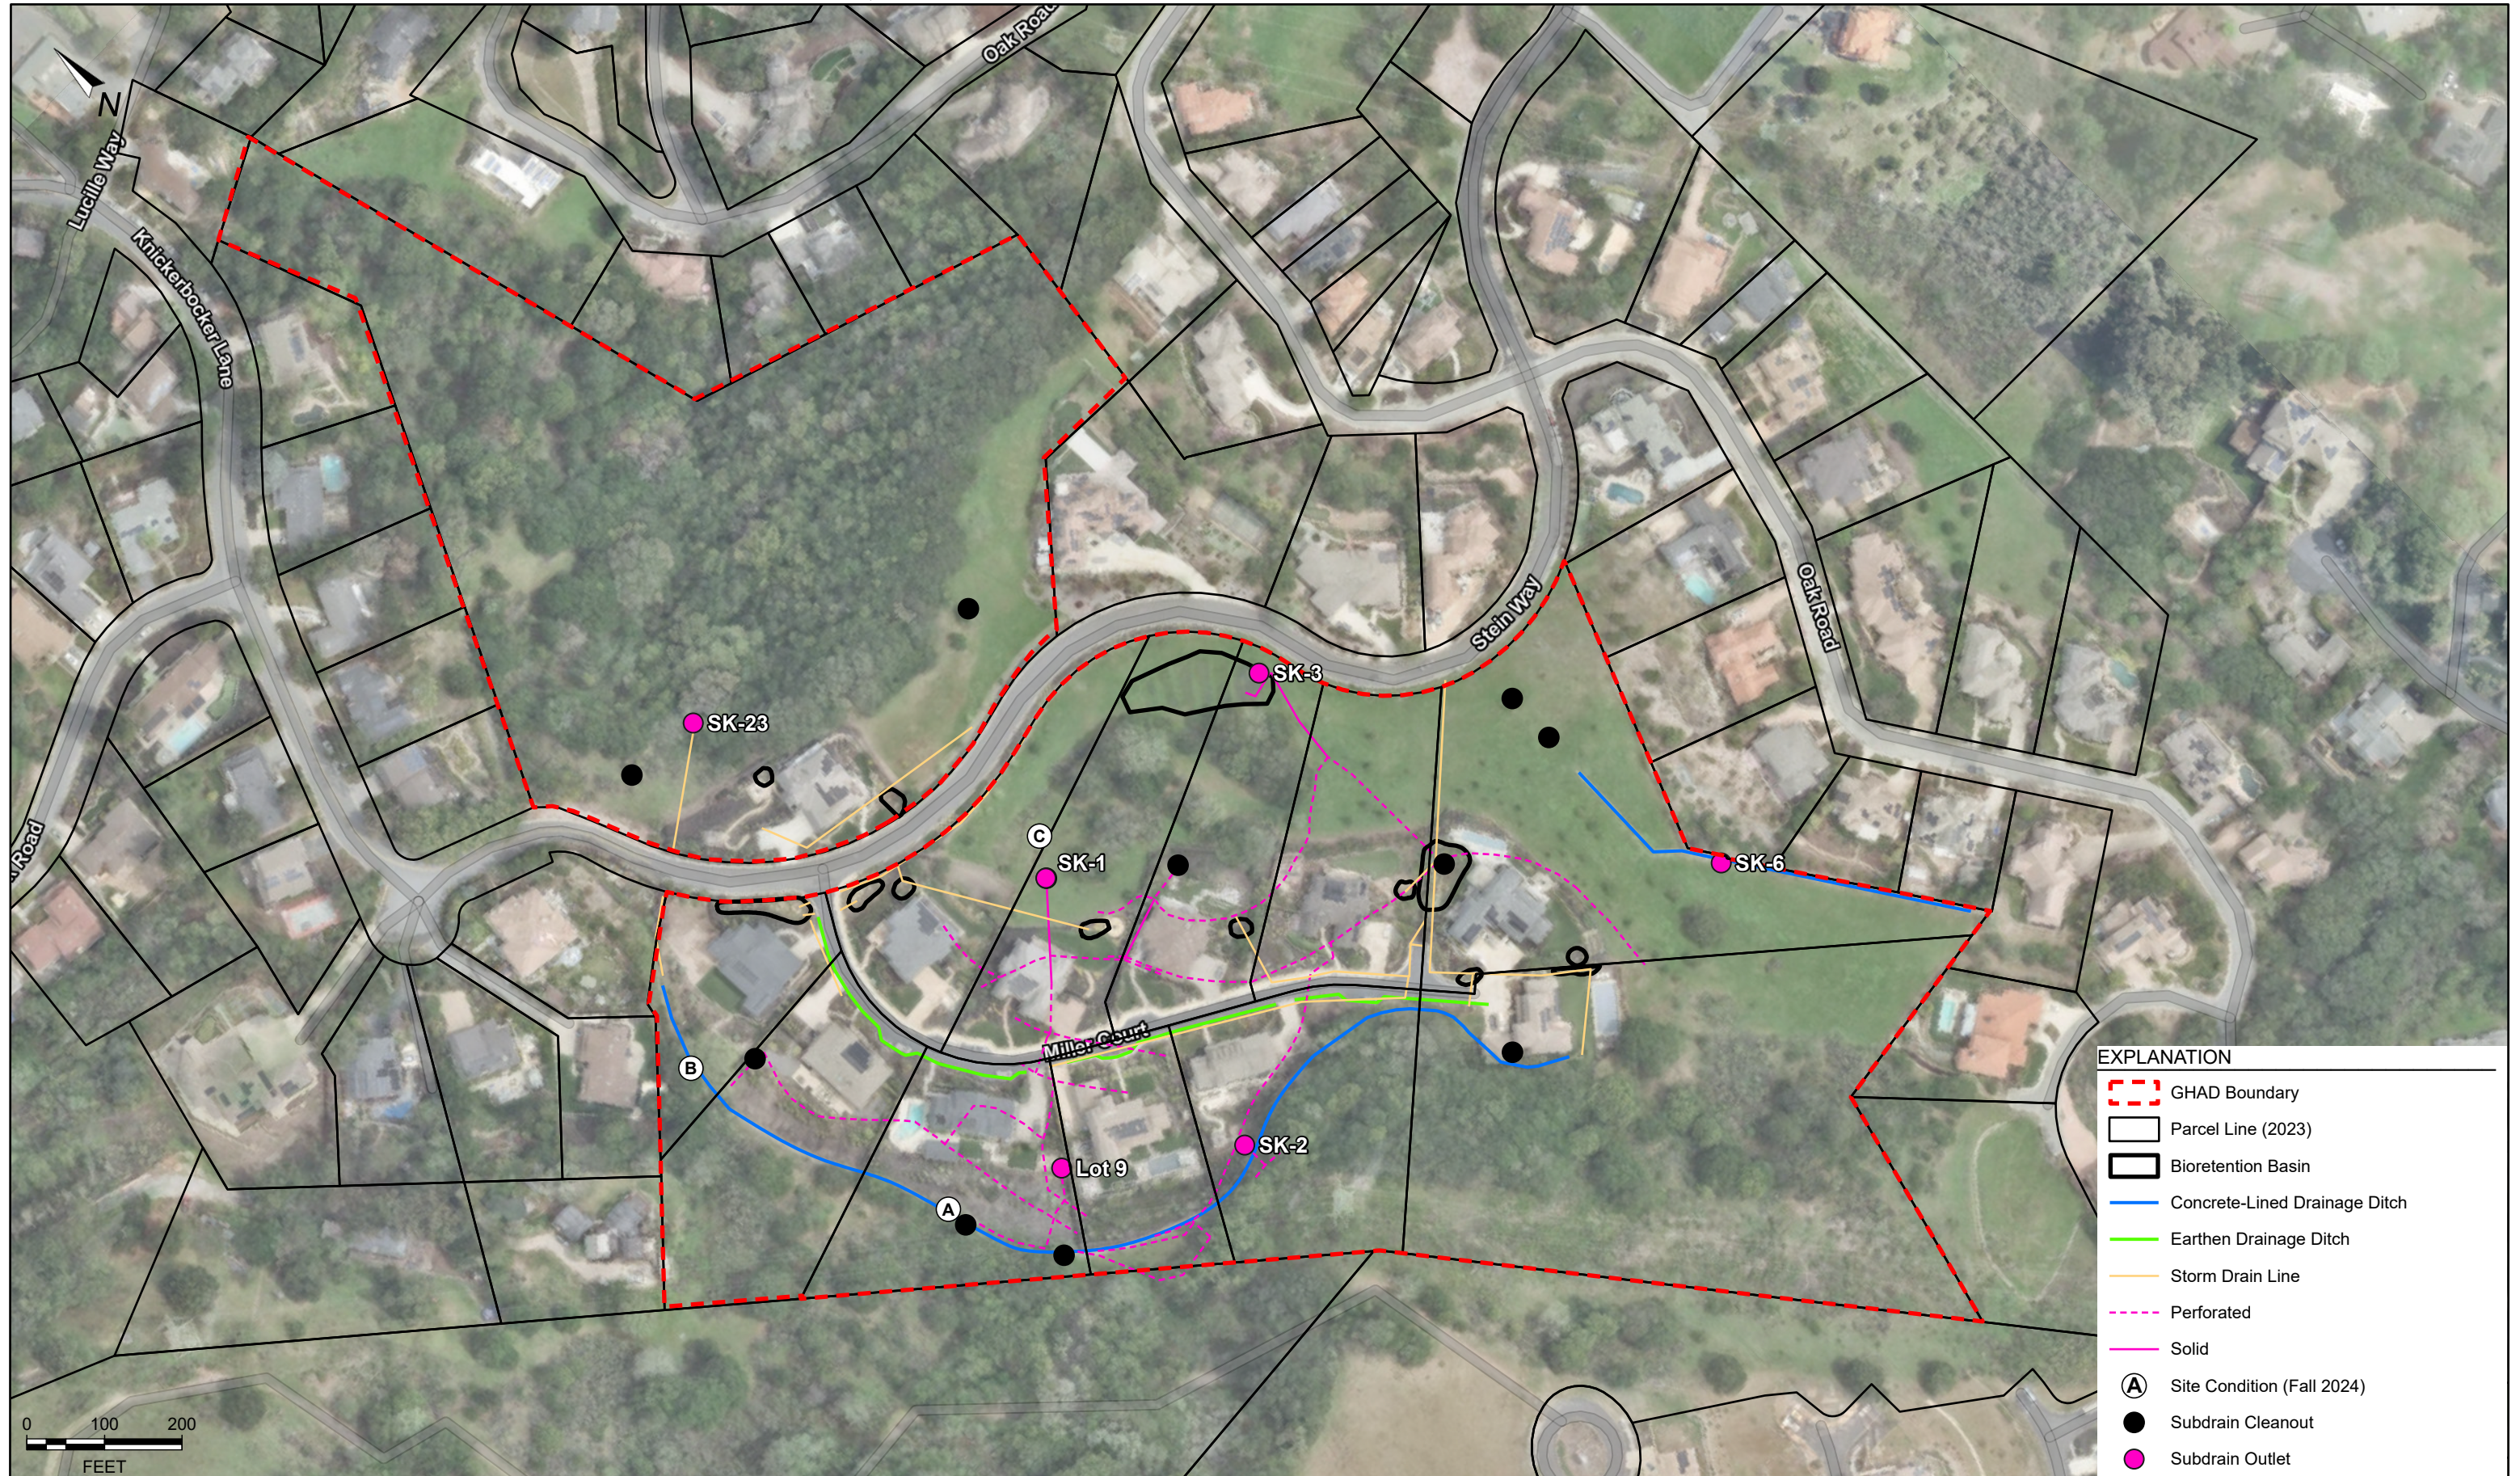
FIGURE 1
SITE PLAN

As shown in Figure 1, there are approximately 800 linear feet of drainage ditches currently maintained by the GHAD. As part of the scheduled routine site maintenance, the GHAD will remove vegetation and other unwanted material from the concrete-lined ditches.
