Project No.  
**4365.002.024**

Subject: Wilder Development  
 Orinda Geologic Hazard Abatement District  
 Orinda, California

**ORINDA GEOLOGIC HAZARD ABATEMENT DISTRICT  
 MONITORING – Spring 2024**

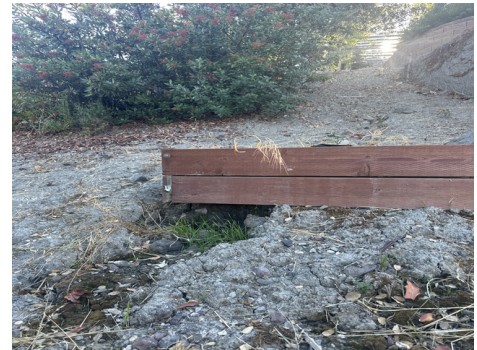
Slopes within the accepted parcels appeared to be performing well, with minor exceptions noted below. During this and our previous monitoring events, we observed a bubbler drain located near the bottom of the slope at 27 Paintbrush Lane, which is being undercut by minor erosion (Site Condition A, Figure 1). This item should be addressed by the homeowner.

Site Condition: A  
Observation Date: 10/21/2024  
Description: Void under bubbler retaining structure.  
Recommendation: Continue to monitor slope.  
Field Representative: QP

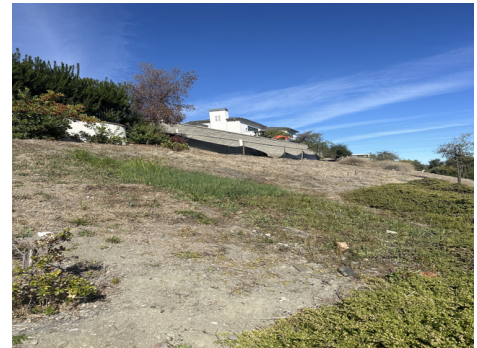
During this and past monitoring events, we observed minor to moderate seepage on the slope within 25 Big Leaf Road (Site Condition B, Figure 1). The seepage appears to be the result of landscape irrigation upslope and was less notable during this inspection. We will continue to monitor the condition of these areas during future monitoring events.

Site Condition: B  
Observation Date: 10/18/2024  
Description: Seepage on slope within 25 Big Leaf Road.  
Recommendation: Continue to monitor.  
Field Representative: QP

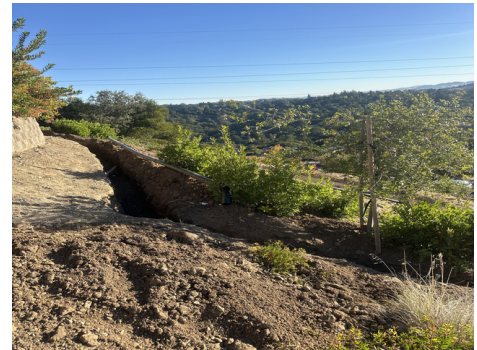
At the time of the Fall 2023 site monitoring, activities related to residential construction were ongoing at the lots around Dairy Creek Lane. During this monitoring event, the construction was ongoing, as well as excessive slope disturbance due to homeowner trenching construction on the slope below 38 Fiddleneck Way (Site Condition C, Figure 1). Repair of any slope damage or addition of erosion control measures will be the responsibility of the homeowners. We will continue to monitor the slope conditions in these areas during future monitoring events.

Site Condition: C  
Observation Date: 10/18/2024  
Description: Existing slope disturbed by homeowner construction/trenching activity.  
Recommendation: Continue to monitor.  
Field Representative: QP

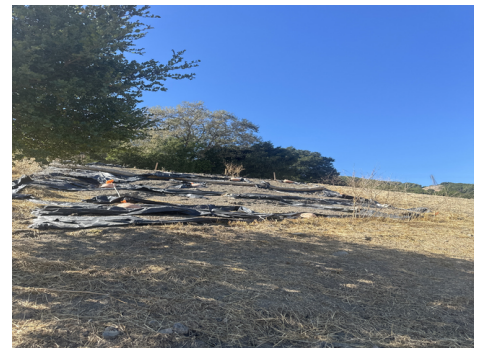
During the previous monitoring event, we observed three shallow landslides on the slope west of 88 Dairy Creek Lane. The first landslide (Site Condition D.1, Figure 1) measured approximately 20 feet in length, 20 feet in width, and 1 foot deep. The second surficial landslide (Site Condition

Site Condition: D.1  
Observation Date: 10/21/2024  
Description: Shallow landslide measuring approximately 20 feet long, 20 feet wide, and 1 foot deep.  
Recommendation: Continue to monitor until repairs are complete. Reapply tarps, sandbags, and straw waddles to cover failure area.  
Field Representative: QP

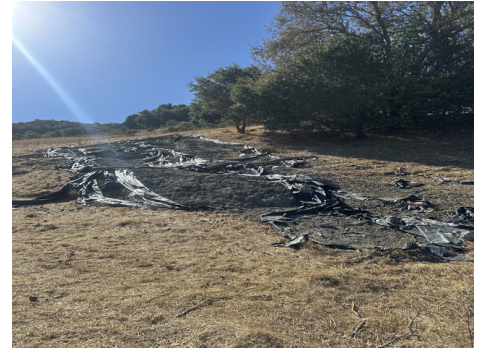
D.2, Figure 1) measured approximately 60 feet in length, 20 feet in width, and up to 3 feet deep. The third landslide (Site Condition D.3, Figure 1) was approximately 30 feet in length, 50 feet wide, and up to 2 feet deep. These were first noted during the Fall 2023 monitoring event and have since been covered with plastic coverings and sandbags to prevent further erosion. During this monitoring event, the plastic coverings and sandbags were observed to be broken and ripped, exposing the soil. The landslides are earthflow-type slides, where the upper soil becomes saturated and flows downhill. At this time, they do not impact current or planned site improvements. The GHAD will re-cover the landslide areas and continue to monitor these landslides until a repair is completed.

Site Condition: D.2  
Observation Date: 10/21/2024  
Description: Shallow landslide measuring approximately 60 feet long, 20 feet wide, and 3 feet deep.  
Recommendation: Continue to monitor until repairs are complete. Reapply tarps, sandbags, and straw waddles to cover failure area.  
Field Representative: QP

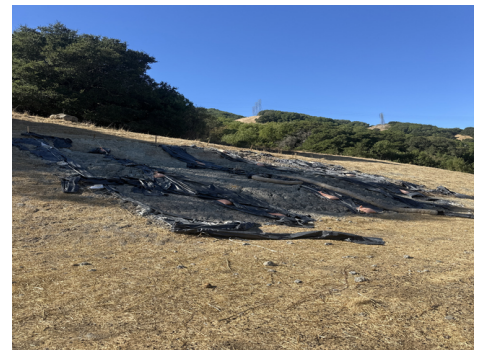
Site Condition: D.3  
Observation Date: 10/21/2024  
Description: Shallow landslide measuring approximately 30 feet long, 50 feet wide, and 2 feet deep.  
Recommendation: Continue to monitor until repairs are complete. Reapply tarps, sandbags, and straw waddles to cover failure area.  
Field Representative: QP

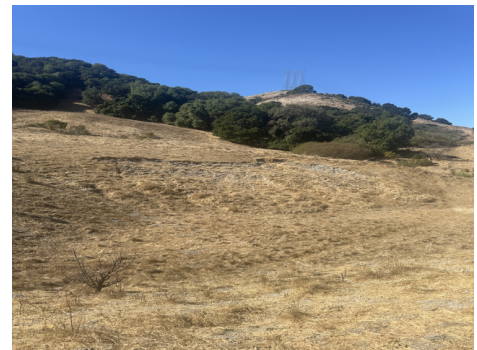
During this monitoring event, we also observed a surficial landslide along the southern slope of the Detention Basin south of Monkeyflower Lane (Site Condition D.4, Figure 1). The landslide is approximately 80 feet in length, 400 feet wide, and 3 feet deep. At this time, it does not impact current or planned site improvements. The GHAD will continue to monitor the landslide.

Site Condition: D.4  
Observation Date: 10/21/2024  
Description: Shallow landslide approximately 80 feet wide, 40 feet tall, and 3 feet deep.  
Recommendation: Continue to monitor.  
Field Representative: QP

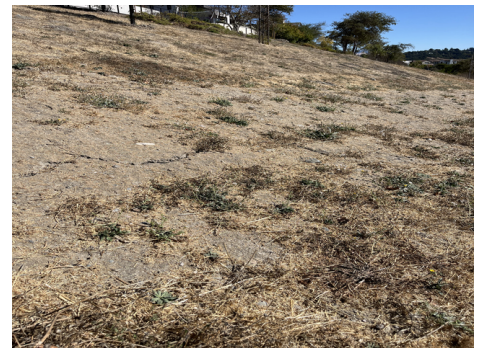
The slope above the retaining wall and concrete drainage ditch to the north of Middle Water Quality Basin 1B, and below 5 Bigleaf Road, showed signs of distress in the form of bare areas without vegetation and desiccation cracking (Site Condition E, Figure 1). This area was previously used as a staging area for nearby construction. The distress does not appear to impact any current or planned site improvements and the GHAD will continue to monitor the area.

Site Condition: E  
Observation Date: 10/18/2024  
Description: Surficial slope distress.  
Recommendation: Continue to monitor.  
Field Representative: QP

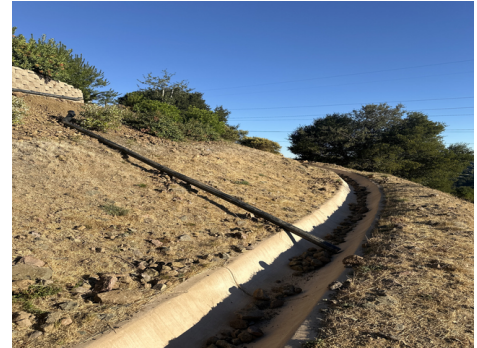
The concrete-lined drainage ditches were checked for accumulation of debris/sediment and for obvious distress such as cracking or shifting of the concrete. Minor amounts of leaves, soil, and some rock were noted in the drainage ditches. One area of significant rock debris deposited in the concrete drainage ditch from homeowner construction was observed below 38 Fiddleneck Way (Site Condition F, Figure 1). The homeowner will be notified to perform maintenance and cleaning of the concrete-lined drainage ditch. Soil and debris will be removed from the ditches during annual GHAD routine maintenance.

Site Condition: F  
Observation Date: 10/18/2024  
Description: Excessive rock debris deposited in concrete drainage ditch from homeowner construction activity.  
Recommendation: Notify homeowner to perform maintenance and cleaning of concrete drainage ditch.  
Field Representative: QP

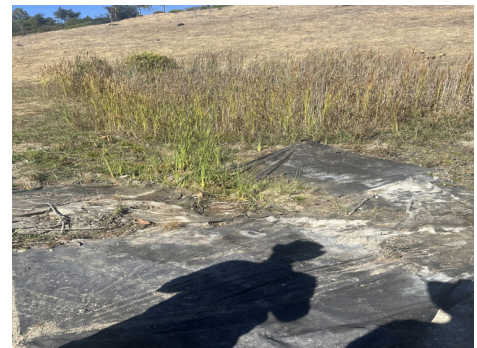
During our previous monitoring event, a storm drain inlet located near 5 Bigleaf Road was observed to have standing water pooled around the inlet, with a silt cover that obstructed the flow of water. We observed the same seepage and sediment buildup during this monitoring event (Site Condition G, Figure 1). The storm drain inlet and silt cover will be repaired during annual maintenance to redirect slope seepage to the storm drain inlet.

Site Condition: G  
Observation Date: 10/18/2024  
Description: Seepage at bottom of slope near 5 Bigleaf Road, and silt covers obstructing storm drain inlet.  
Recommendation: Remove debris from storm drain inlet during annual maintenance.  
Field Representative: QP

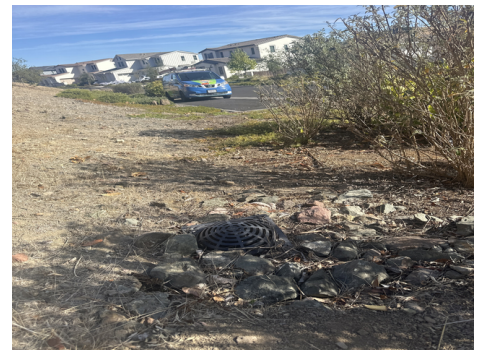
Site Condition: H.1  
Observation Date: 10/18/2024  
Description: Obstructed bubbler drain.  
Recommendation: Remove debris from bubbler drain during annual maintenance.  
Field Representative: QP

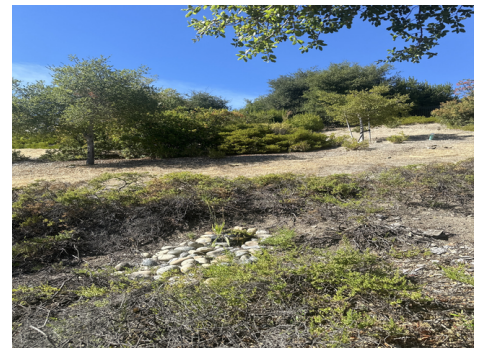
Site Condition: H.2  
Observation Date: 10/18/2024  
Description: Obstructed bubbler drain.  
Recommendation: Remove debris from bubbler drain during annual maintenance.  
Field Representative: QP

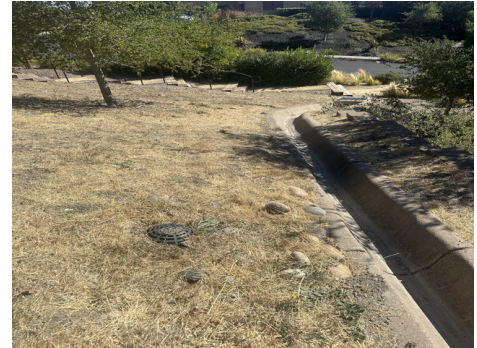
Site Condition: H.3  
Observation Date: 10/18/2024  
Description: Obstructed bubbler drain.  
Recommendation: Remove debris from bubbler drain during annual maintenance.  
Field Representative: QP

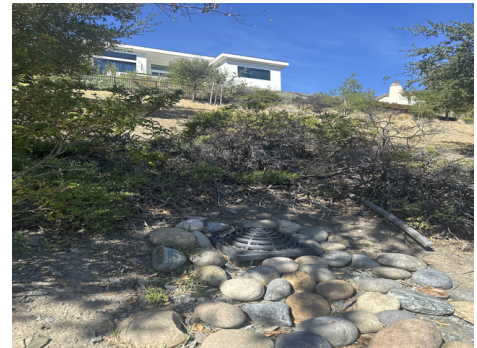
Site Condition: H.4  
Observation Date: 10/18/2024  
Description: Obstructed bubbler drain.  
Recommendation: Remove debris from bubbler drain during annual maintenance.  
Field Representative: QP

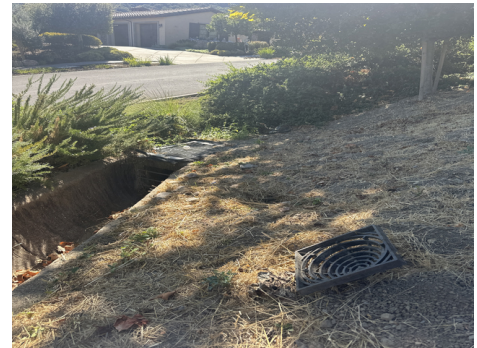
Site Condition: H.5  
Observation Date: 10/18/2024  
Description: Obstructed bubbler drain.  
Recommendation: Remove debris from bubbler drain during annual maintenance.  
Field Representative: QP

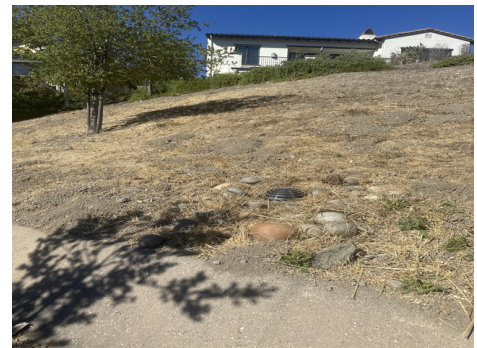
Site Condition: H.6  
Observation Date: 10/18/2024  
Description: Obstructed bubbler drain.  
Recommendation: Remove debris from bubbler drain during annual maintenance.  
Field Representative: QP

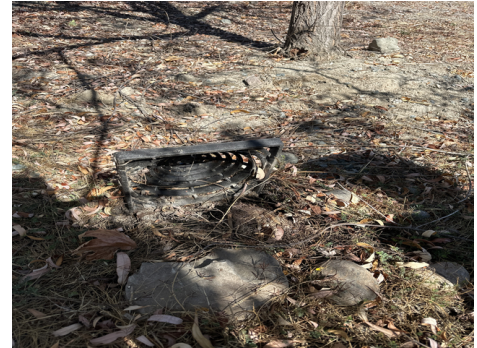
Site Condition: H.7  
Observation Date: 10/18/2024  
Description: Obstructed bubbler drain.

Recommendation: Remove debris from bubbler drain during annual maintenance.

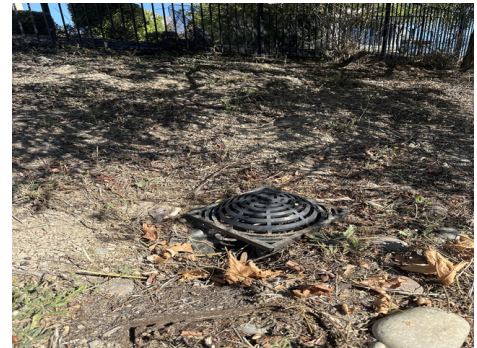
Site Condition: H.8  
Observation Date: 10/18/2024  
Description: Obstructed bubbler drain.

Recommendation: Remove debris from bubbler drain during annual maintenance.

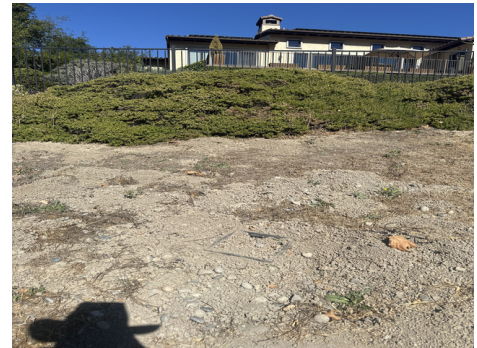
Site Condition: H.9  
Observation Date: 10/18/2024  
Description: Obstructed bubbler drain.

Recommendation: Remove debris from bubbler drain during annual maintenance.

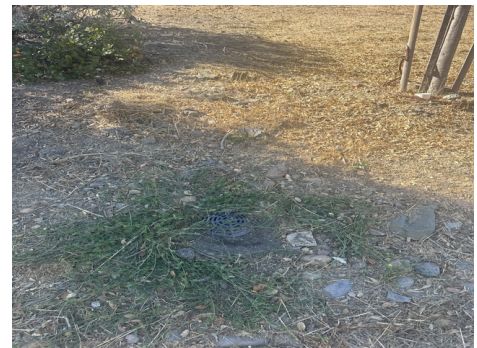
Site Condition: H.10  
Observation Date: 10/21/2024  
Description: Obstructed bubbler drain.

Recommendation: Remove debris from bubbler drain during annual maintenance.

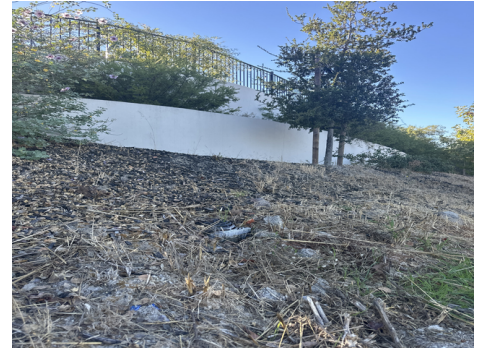
Site Condition: H.11  
Observation Date: 10/21/2024  
Description: Obstructed bubbler drain.

Recommendation: Remove debris from bubbler drain during annual maintenance.

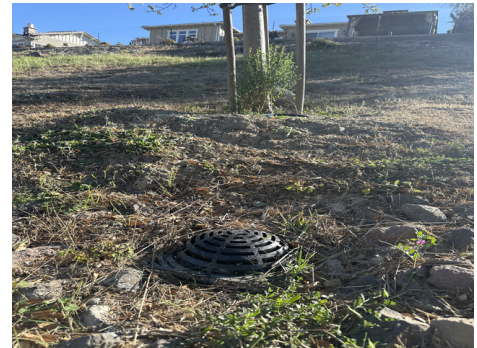
Site Condition: H.12  
Observation Date: 10/18/2024  
Description: Obstructed bubbler drain.

Recommendation: Remove debris from bubbler drain during annual maintenance.
