Project No.
4365.002.025

October 14, 2025

Subject: Orinda Oaks Development
 Orinda, California

**ORINDA GEOLOGIC HAZARD ABATEMENT DISTRICT
 MONITORING – FALL 2025**

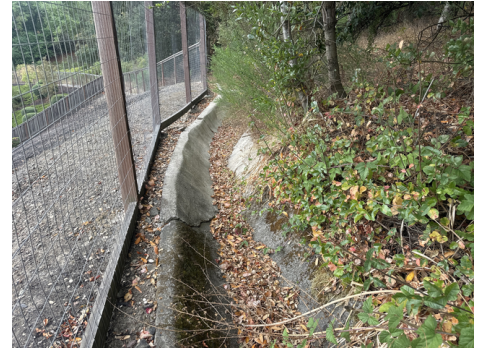
We have previously observed moderate cracks and offsets in the concrete ditch on the western portion of 320 Miller Court (Lot 9) with a measured ½-inch vertical displacement and ¼-inch horizontal displacement (Figure 1, Site Condition A). We have also previously observed an offset in the concrete-lined drainage ditch on the western portion of 300 Miller Court (Lot 11), with a measured 2-inch vertical displacement and 1-inch horizontal displacement (Figure 1, Site Condition B). During this monitoring event, these offsets in the concrete-lined drainage ditches appear unchanged. The cracks and offsets do not appear to compromise the integrity of the concrete-lined drainage ditches. The GHAD will continue to monitor these conditions in future monitoring events.

Site Condition: A
Observation Date: 09/29/2025
Description: Crack and offset in concrete-lined drainage ditch behind 320 Miller Court.
Recommendation: Continue to monitor.
Field Representative: QP

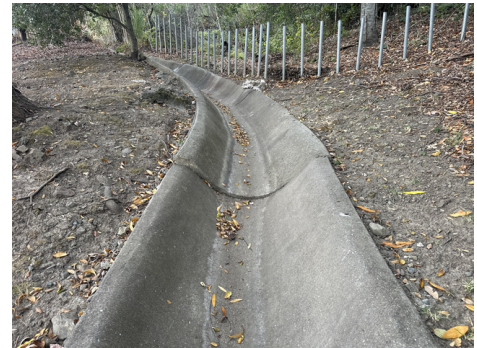
Site Condition: B
Observation Date: 09/29/2025
Description: Offset in concrete-lined drainage ditch behind 300 Miller Court.
Recommendation: Continue to monitor.
Field Representative: QP

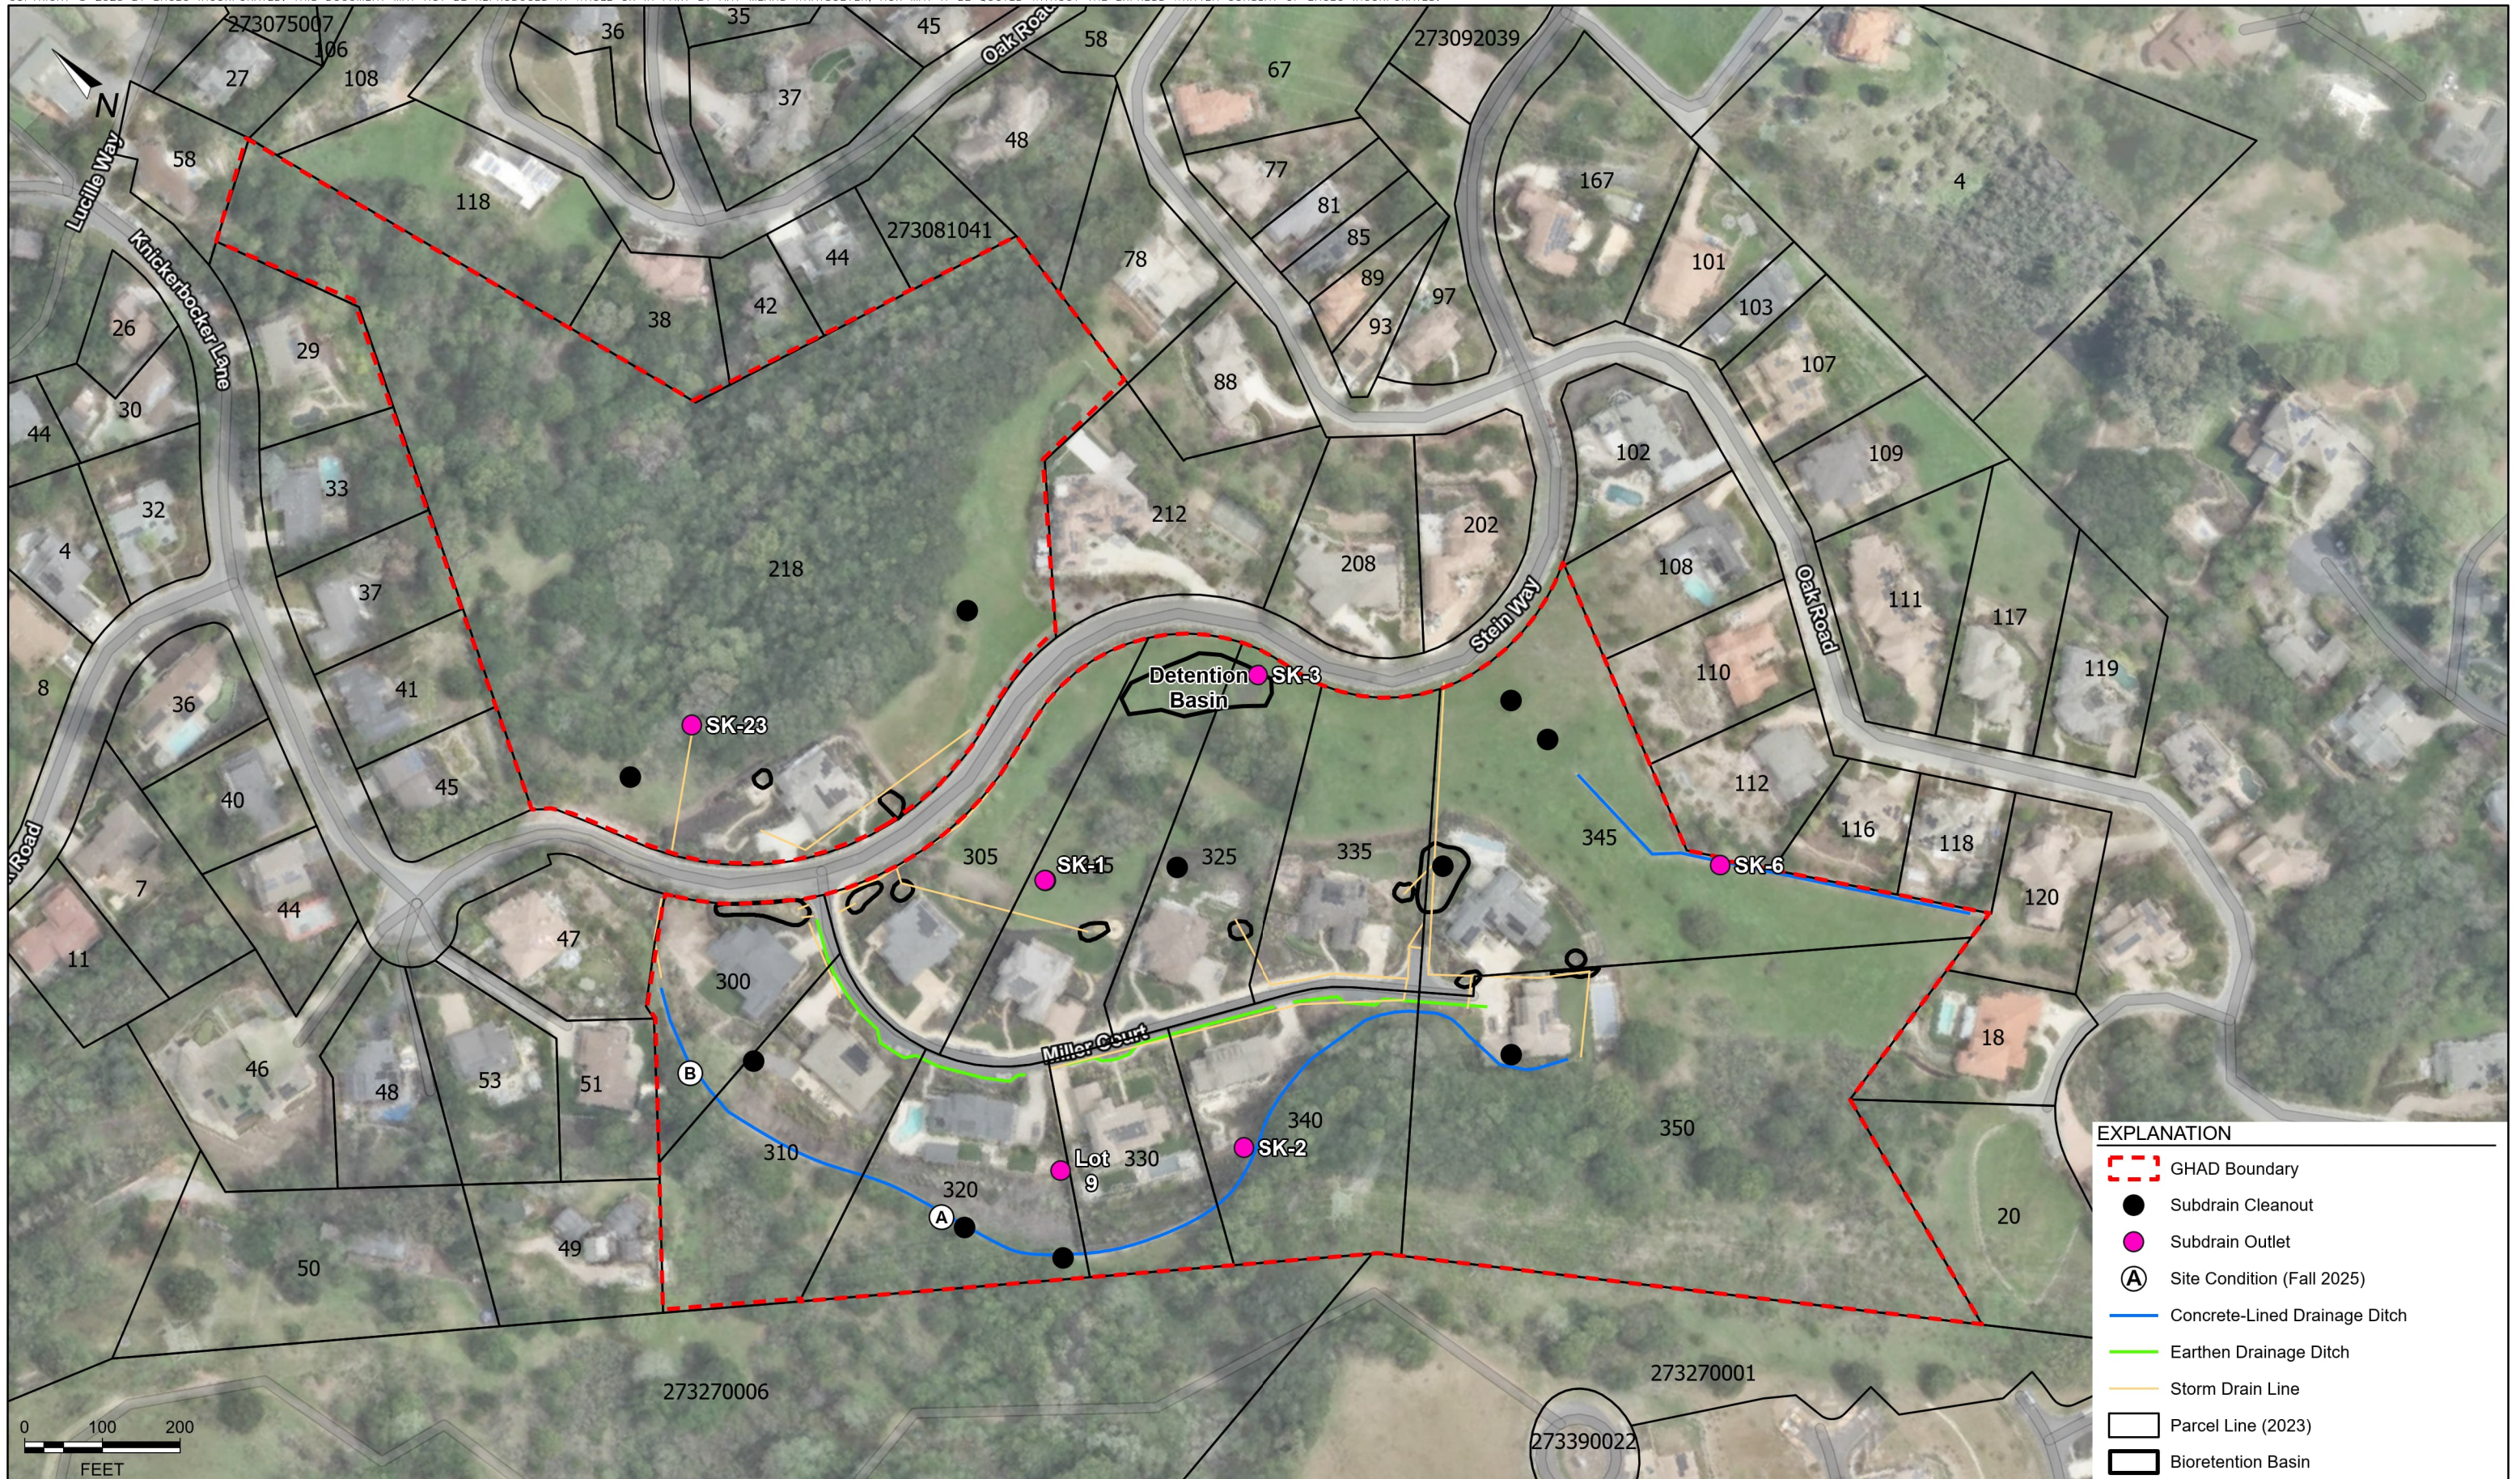
FIGURE 1

As shown in Figure 1, there are approximately 800 linear feet of drainage ditches currently maintained by the GHAD. As part of the scheduled routine site maintenance, the GHAD will remove vegetation and other unwanted material from the concrete-lined ditches.
