Project No.
4365.002.025

October 15, 2025

Subject: Wilder Development
 Orinda Geologic Hazard Abatement District
 Orinda, California

**ORINDA GEOLOGIC HAZARD ABATEMENT DISTRICT
 MONITORING – FALL 2025**

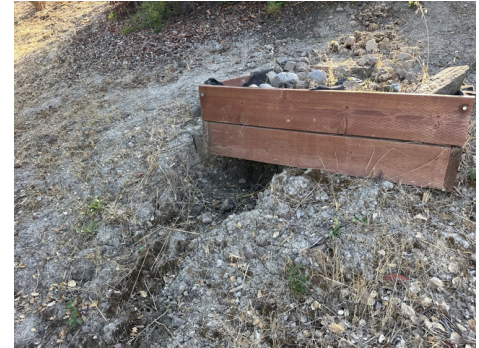
Slopes within the accepted parcels appeared to be performing well, with minor exceptions noted below. During this and our previous monitoring events, we observed a bubbler drain located near the bottom of the slope at 27 Paintbrush Lane, which is being undercut by minor erosion (Site Condition A, Figure 1). This item should be addressed by the homeowner.

Site Condition: A
Observation Date: 09/26/2025
Description: Void under bubbler retaining structure.
Recommendation: Continue to monitor slope.
Field Representative: QP

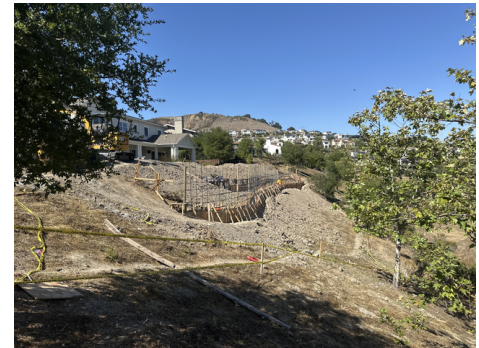
Since our Fall 2023 site monitoring, activities related to residential construction have been ongoing at the lots around Dairy Creek Lane. We also observed residential construction activity at 37 Big Leaf Road and 25 Frogs Leap Way during this monitoring event. Excessive loose soil related to the construction at 25 Frogs Leap Way was observed on the slope face below (Site Condition B, Figure 1). Repair of any slope damage or addition of erosion control measures will be the responsibility of the homeowners. The GHAD will continue to monitor the slope conditions in these areas during future monitoring events.

Site Condition: B
Observation Date: 09/26/2025
Description: Homeowner construction activity and loose soil along slope.
Recommendation: Homeowner to repair slope upon completion. Continue to monitor.
Field Representative: QP

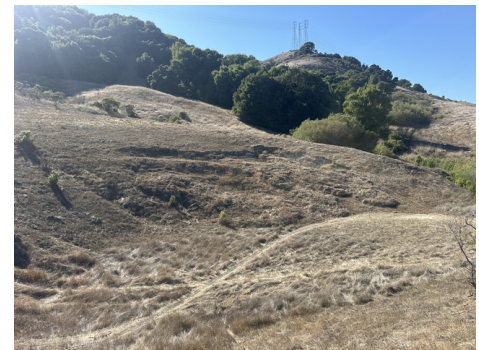
During the Fall 2024 monitoring event, we observed a surficial landslide along the southern slope of the Detention Basin south of Monkeyflower Lane (Site Condition C.1, Figure 1). The landslide is approximately 80 feet wide, 40 feet tall, and 3 feet deep. At this time, it does not impact current or planned site improvements. The GHAD will continue to monitor the landslide. We previously observed another surficial landslide above the maintenance road along Orinda Fields Lane near Wilder Road (Site Condition C.2, Figure 1). The landslide is approximately 30 feet wide, 20 feet tall, and 3 feet deep. The landslide appeared to have been covered in the past, but the material

has since weathered and broken down. At this time, it does not impact current or planned site improvements and appears unchanged from the previous monitoring event. The GHAD will continue to monitor the landslide.

Site Condition: C.1
Observation Date: 09/26/2025
Description: Shallow landslide approximately 80 feet wide, 40 feet tall, and 3 feet deep.
Recommendation: Continue to monitor.
Field Representative: QP

| MONITORED CONTROL | YES | NO | N/A | COMMENTS/ SUGGESTED MAINTENANCE |
|--|---|---|---|---|
| 5. Is the embankment surrounding the basin in good condition without rills or failures? | | X | | Shallow landslide approximately 80 feet wide, 40 feet tall, and 3 feet deep along southwestern slope (Site Condition C.1) |

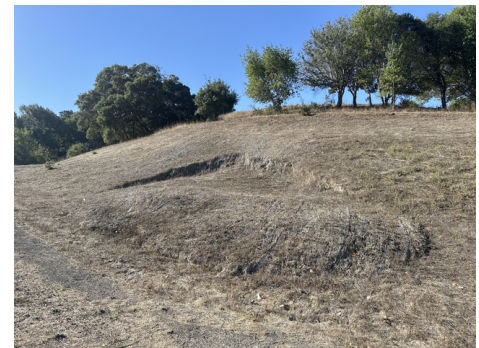
During the previous monitoring events, we observed three shallow landslides on the slope west of 88 Dairy Creek Lane. These were first noted during the Fall 2023 monitoring event and had been covered with plastic coverings and sandbags to prevent further erosion. Repairs of the three landslides are in progress at the time of this monitoring event. The GHAD will continue to monitor the area once the repairs are complete.

Site Condition: C.2
Observation Date: 09/26/2025
Description: Shallow surficial landslide approximately 30 feet wide, 20 feet tall, and 3 feet deep.
Recommendation: Continue to monitor.
Field Representative: QP

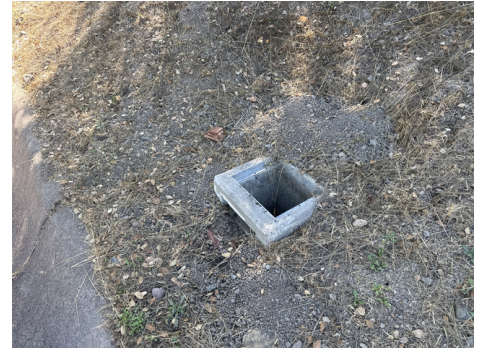
Drain bubblers located near the base of the slope at several lots were observed to be clogged with soil and debris or were missing top grates during our previous monitoring event. The debris was removed and top grates were replaced as part of the GHAD’s routine annual maintenance. During this monitoring event, one bubbler drain was observed to be missing a top grate cover (Site Condition D, Figure 1). The grate will be replaced as part of the GHAD’s annual maintenance.

Site Condition: D
Observation Date: 09/26/2025
Description: Bubbler drain missing top grate.

Recommendation: Replace grate during annual maintenance.
