Project No.
4365.002.025

October 15, 2025

Subject: Wilder Development
 Orinda Geologic Hazard Abatement District
 Orinda, California

**ORINDA GEOLOGIC HAZARD ABATEMENT DISTRICT
 MONITORING – FALL 2025**

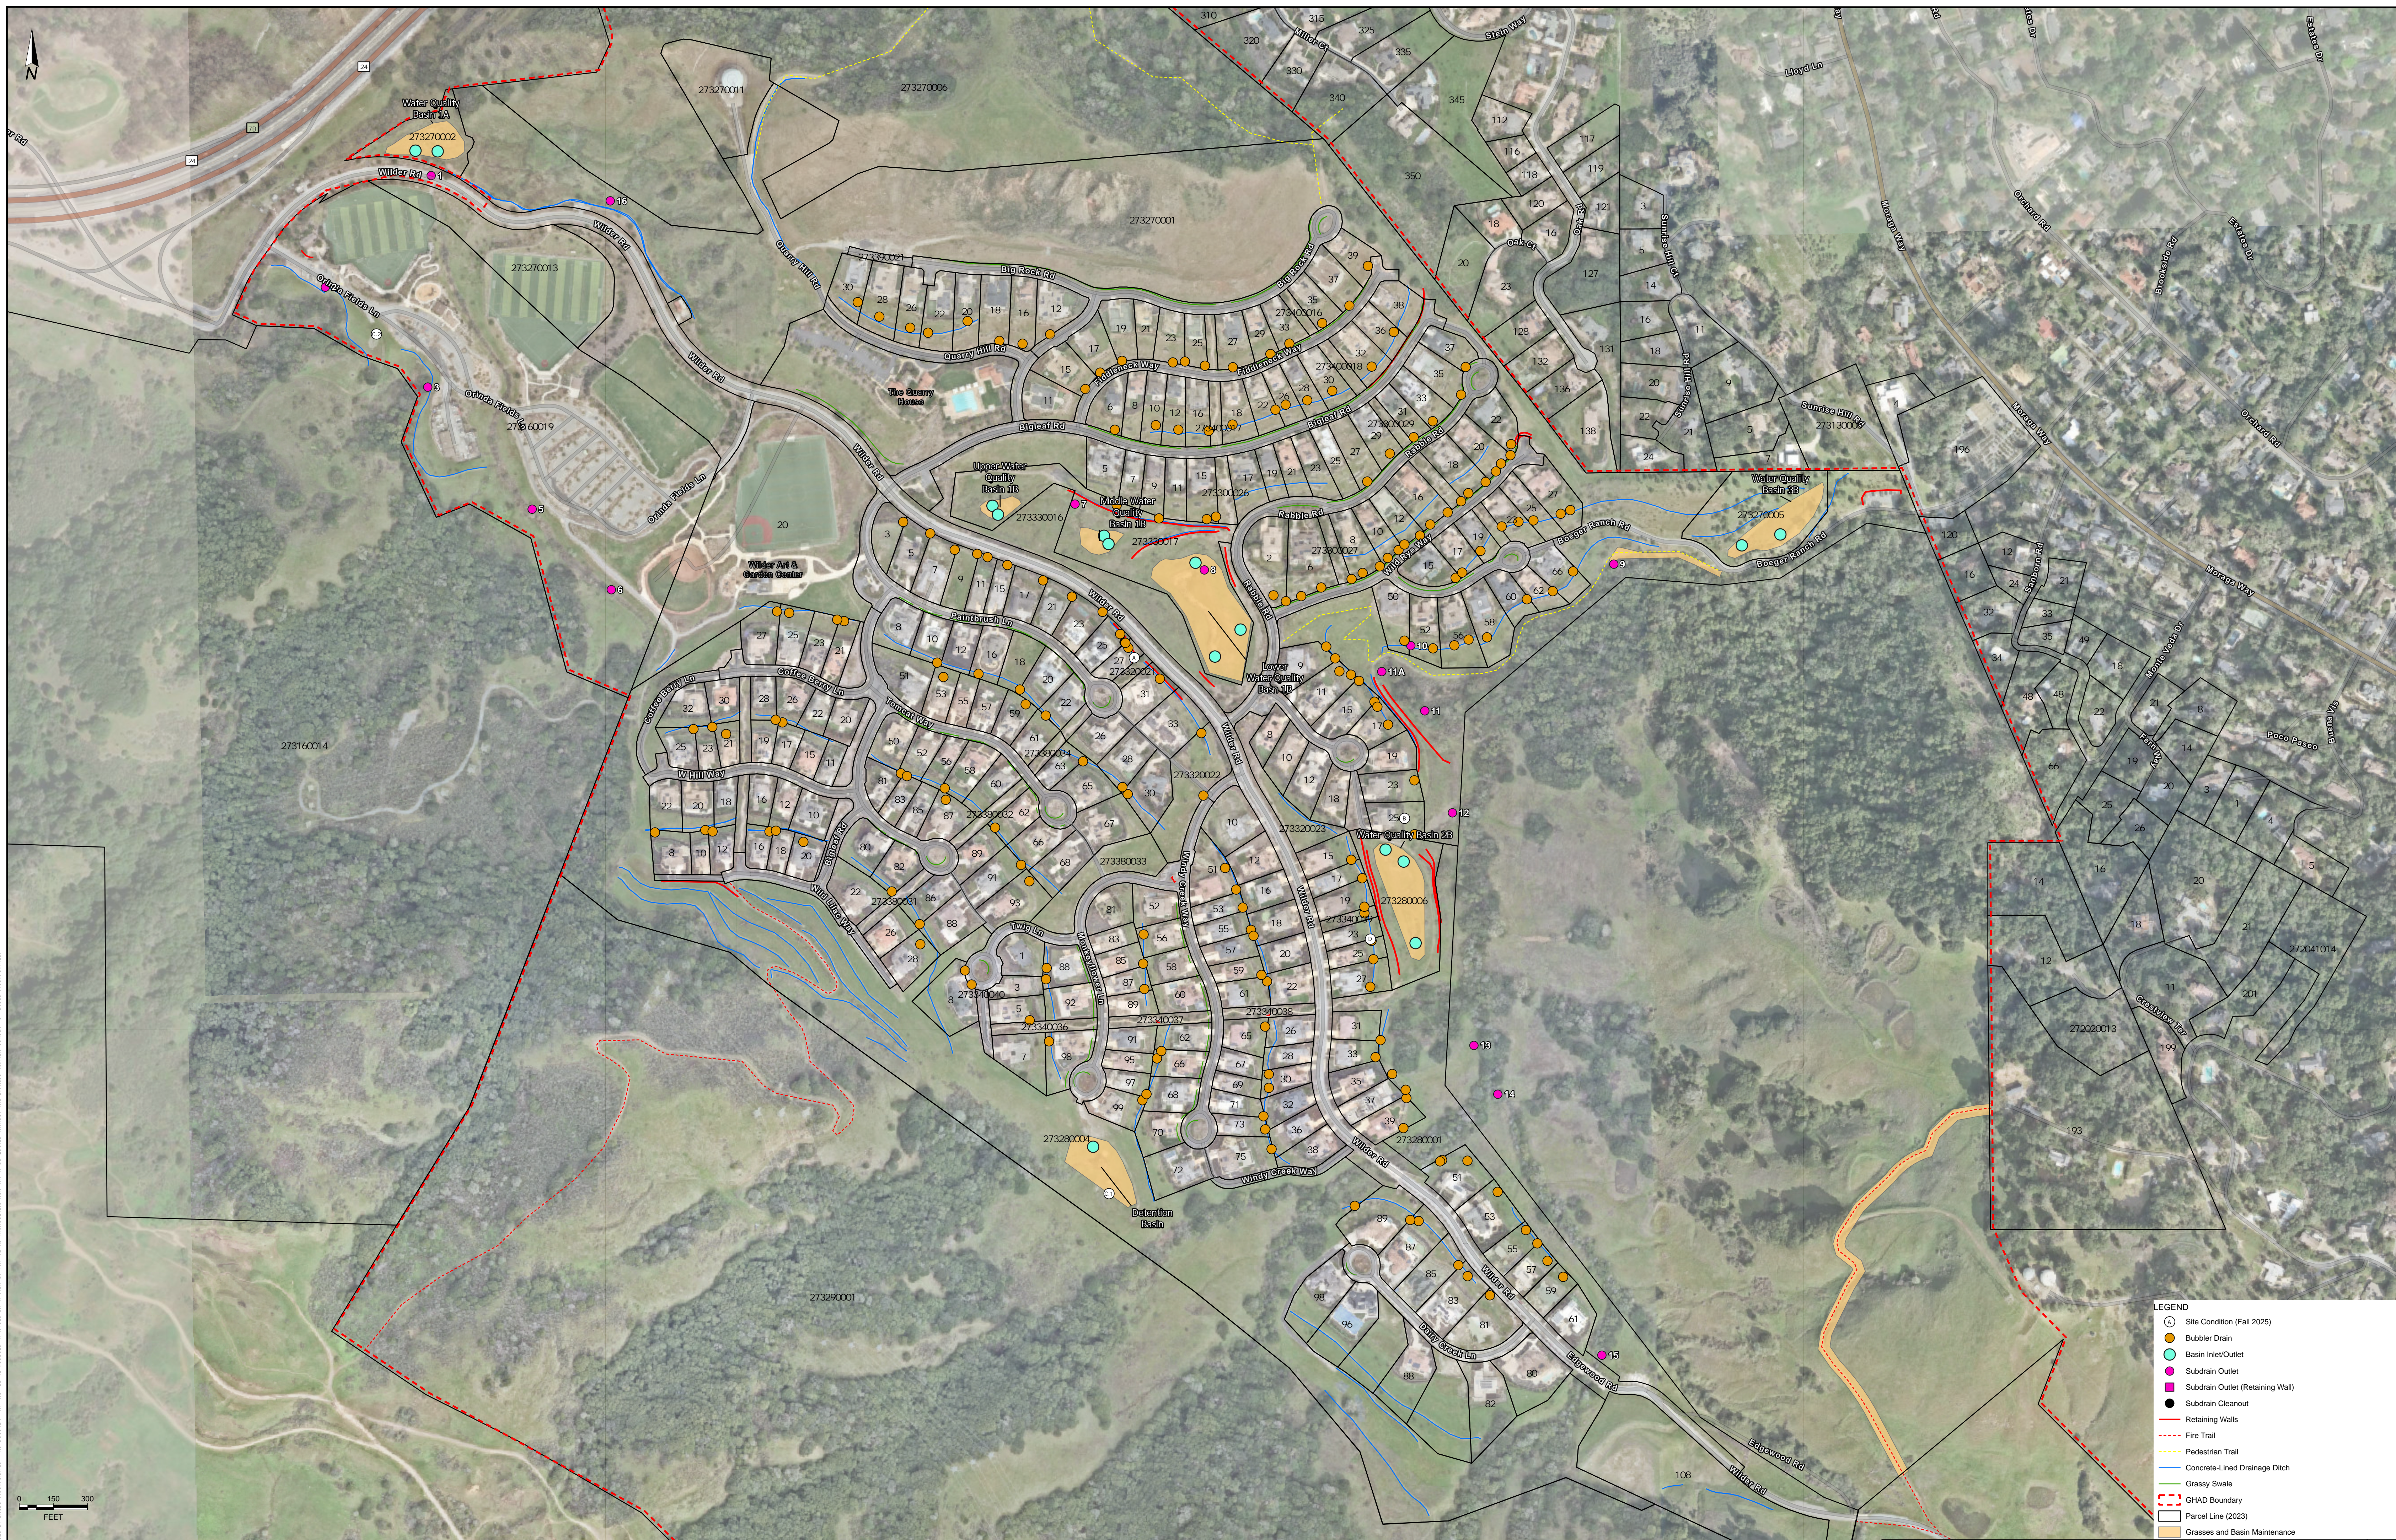
FIGURE 1
SITE PLAN

Slopes within the accepted parcels appeared to be performing well, with minor exceptions noted below. During this and our previous monitoring events, we observed a bubbler drain located near the bottom of the slope at 27 Paintbrush Lane, which is being undercut by minor erosion (Site Condition A, Figure 1). This item should be addressed by the homeowner.

During the Fall 2024 monitoring event, we observed a surficial landslide along the southern slope of the Detention Basin south of Monkeyflower Lane (Site Condition C.1, Figure 1). The landslide is approximately 80 feet wide, 40 feet tall, and 3 feet deep. At this time, it does not impact current or planned site improvements. The GHAD will continue to monitor the landslide. We previously observed another surficial landslide above the maintenance road along Orinda Fields Lane near Wilder Road (Site Condition C.2, Figure 1). The landslide is approximately 30 feet wide, 20 feet tall, and 3 feet deep. The landslide appeared to have been covered in the past, but the material

Drain bubblers located near the base of the slope at several lots were observed to be clogged with soil and debris or were missing top grates during our previous monitoring event. The debris was removed and top grates were replaced as part of the GHAD’s routine annual maintenance. During this monitoring event, one bubbler drain was observed to be missing a top grate cover (Site Condition D, Figure 1). The grate will be replaced as part of the GHAD’s annual maintenance.
