**FIRST AMENDED PLAN OF CONTROL
ORINDA GEOLOGIC HAZARD ABATEMENT DISTRICT
PLAN OF CONTROL FOR ORINDA OAKS**

Prepared by:
ENGEO Incorporated

April 5, 2013
Revised May 22, 2013

Project No.
9192.000.001

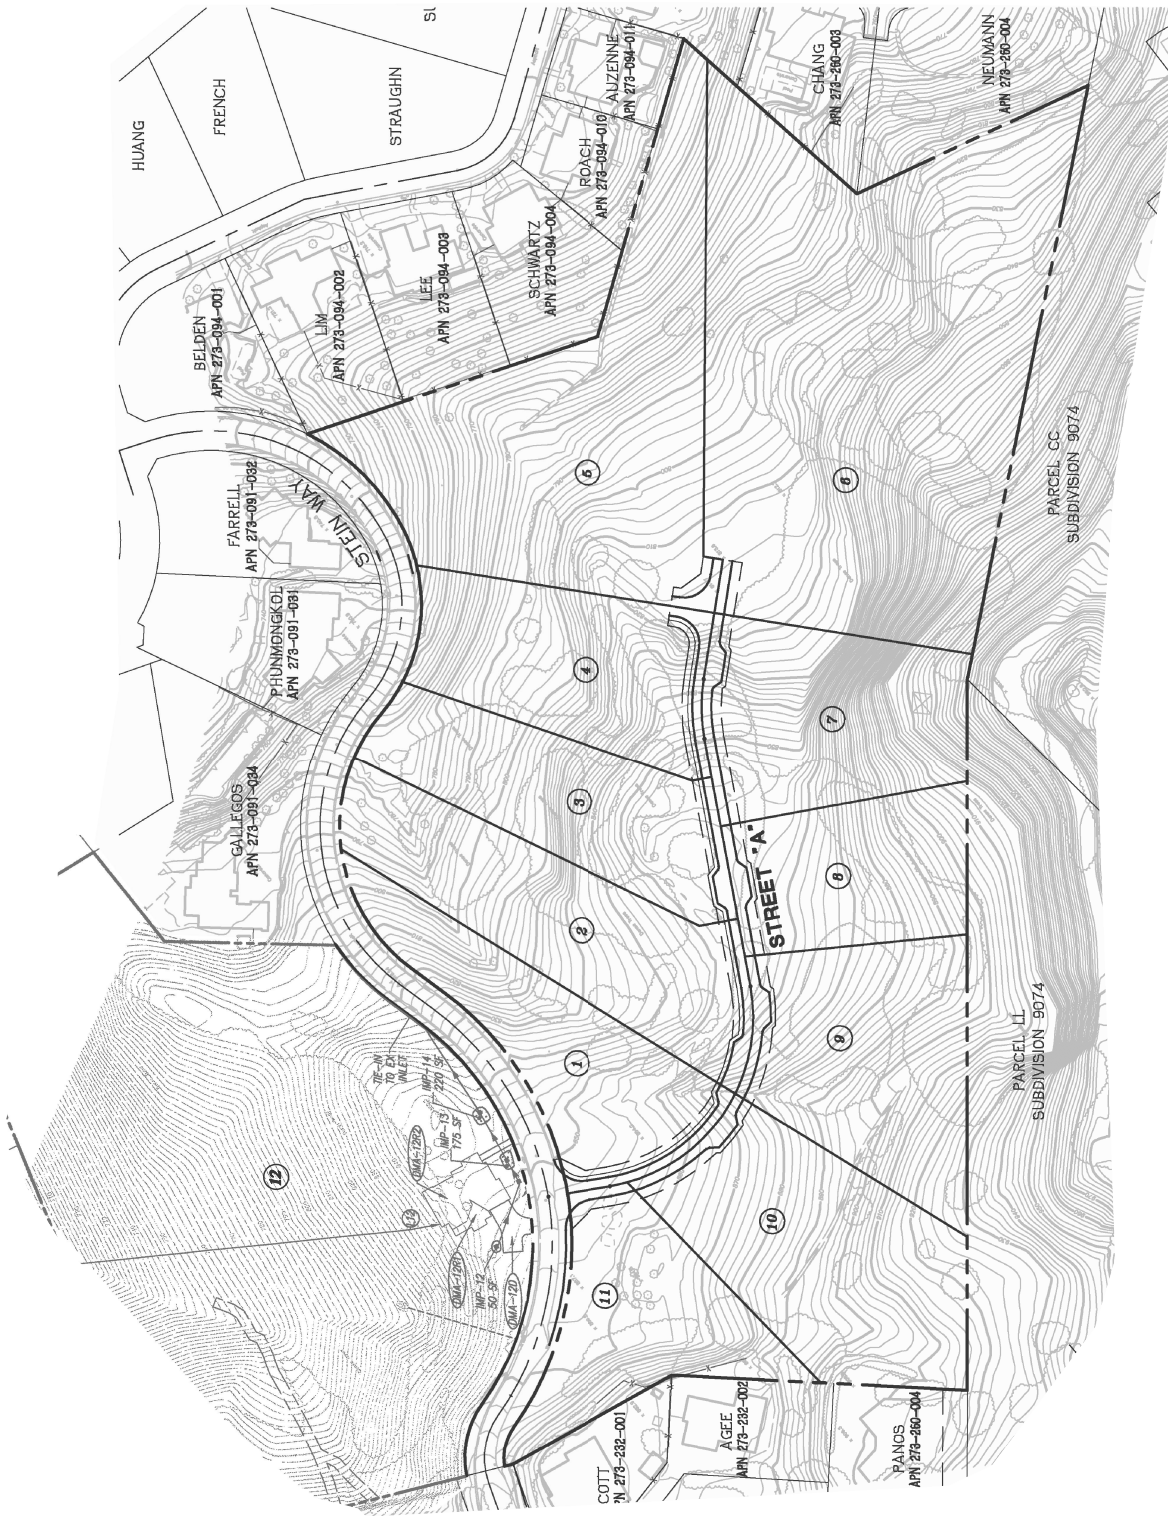
Colluvium, typically consisting of consisting of stiff silty clay with gravel, underlies steep swale areas west of the Project as depicted on Figure 2.

A colluvial terrace deposit is present on a portion of Lot 6 and the adjacent Wilder Project. This deposit appears to consist of dense gravelly to bouldery clay (Figure 2).

Landslide deposits consist of masses of unconsolidated material and/or bedrock that have moved downslope under the influence of gravity by sliding, falling, or flowing. Landslides designated on the Project as 1, 1A, 3, 4, 5, 6, and 7 have been partially replaced with subdrained engineered fill (Figure 2). The remaining landslide materials, with the exception of Landslide S-26, were described in the May 2000 Geotechnical Engineering Investigation (Jensen-Van Lienden Associates, Inc.) as a silty clay matrix with basalt fragments. Exploratory test pits completed within the limits of Landslide S-26 (ENGEO Landslide No. 4) in 2008 identified similar landslide materials comprising a silty clay matrix with basalt fragments.

During mapping for certain of the Reports, designated landslide areas were identified. The geologic map, showing the location of each of the landslide areas, is included as Figure 2. The table below identifies each of the landslide areas and the proposed corrective measures. The proposed corrective measures to be performed by the Project Developer were identified in the Supplemental Geotechnical Investigation and supplemental reports. Potential Orinda GHAD monitoring or maintenance activities for the specific areas listed in the table below are discussed in Section 8 of this Plan of Control.
